Retrofit against fatigue cracking at web penetration details with a slot in steel girder

To cite this article: Chihiro Sakamoto *et al* 2018 *IOP Conf. Ser.: Mater. Sci. Eng.* **419** 012008

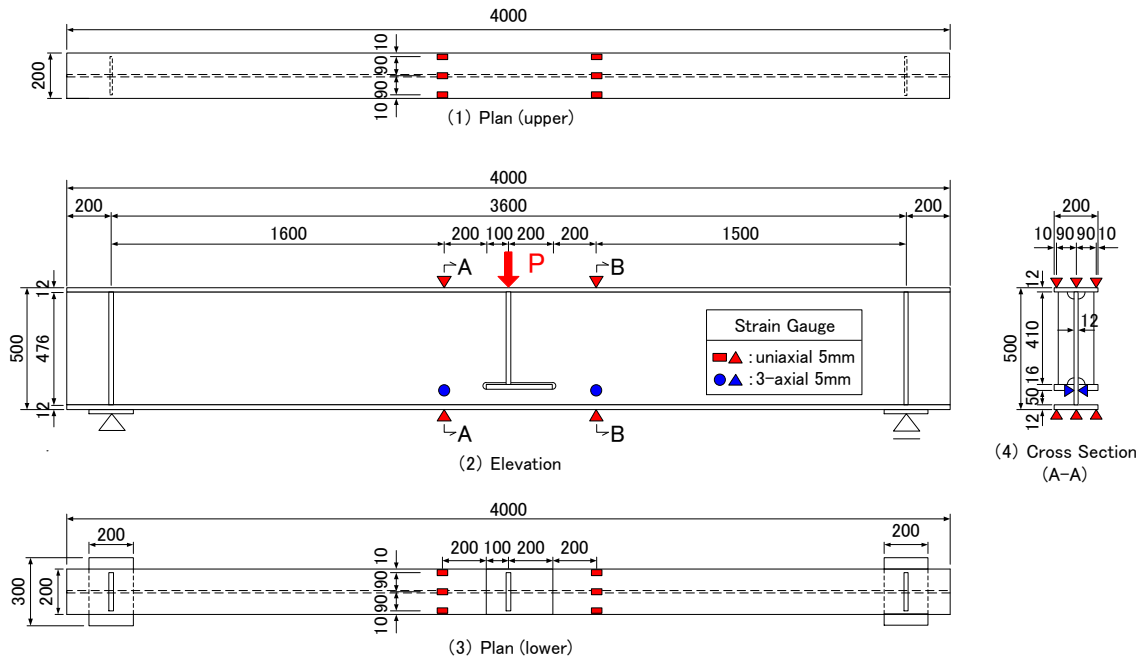
Figure 1. Configurations and dimensions of specimen

We designed and fabricated two type steel girder specimens with web penetration details where a cross beam lower flange was connected to each upper or lower surface of a slot by fillet welding. Figure 1 shows configurations and dimensions of each specimens; upper welded specimens (U1, U2), lower welded specimens (L1, L2), and Figure 2 shows the location of strain gauges. The number of

specimens is two for each type. The specimen has a slot in the lower center of steel girder web. The material is JIS 490YA steel. Submerged arc welding was used to connect web and flanges, while CO₂ arc welding was used to connect the other members.

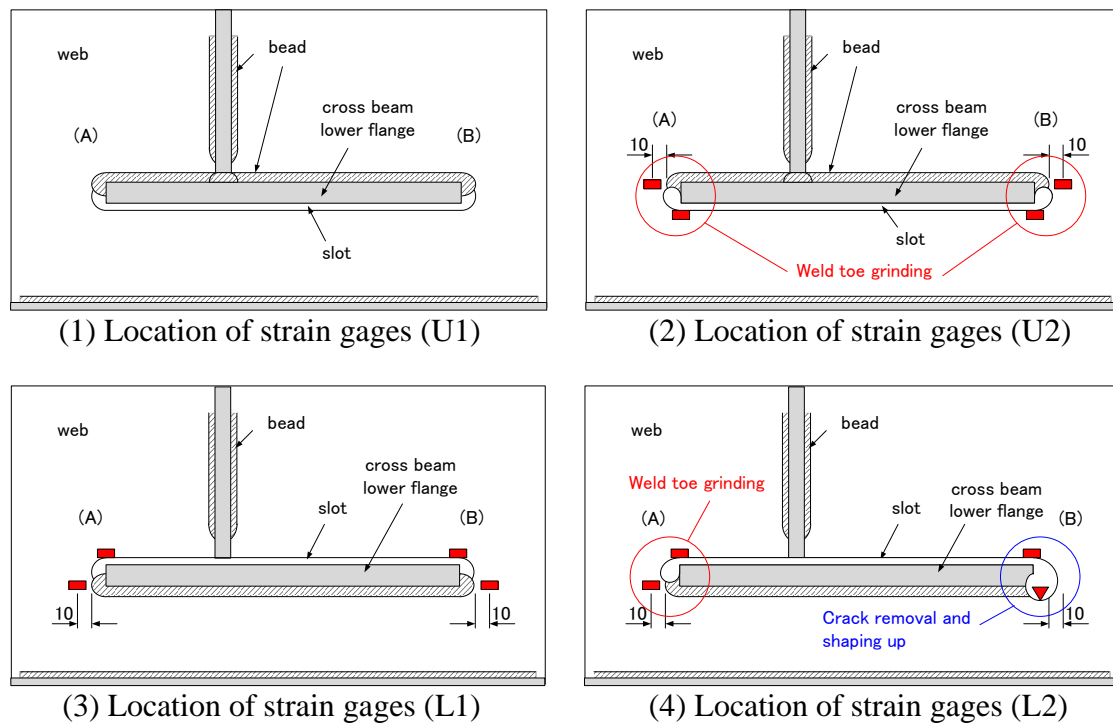
Figure 2. location of strain gauges

First, we conducted static loading test in 3-point bending condition to grasp the stress distributions around web penetration details. 3-axis strain gauges were pasted on both surfaces of the web plate horizontally 100mm away from cross beam lower flange edges to avoid the influence of the stress

concentration near the welded joint. Three 1-axis strain gauges were pasted on the upper surface of upper flange and the lower surface of lower flange in the cross section where 3-axis strain gauges were pasted. The test load was set to 100kN so that the maximum tensile stress of about 50MPa might be generated in the lower flange considering the live-load stress.

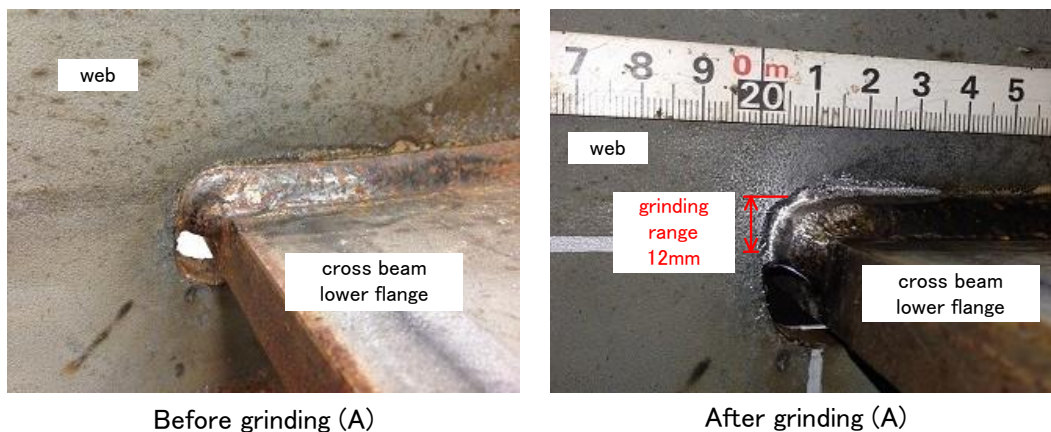
Before grinding (A)
After grinding (A)
Photo 1. Condition of ground weld toe (U2 (A))

Weld toes were ground using a bar grinder in the upper welded specimen U2 (A and B), and the lower welded specimen L2 (A). Photo 1 shows the condition of ground weld toe of U2 specimen (A).

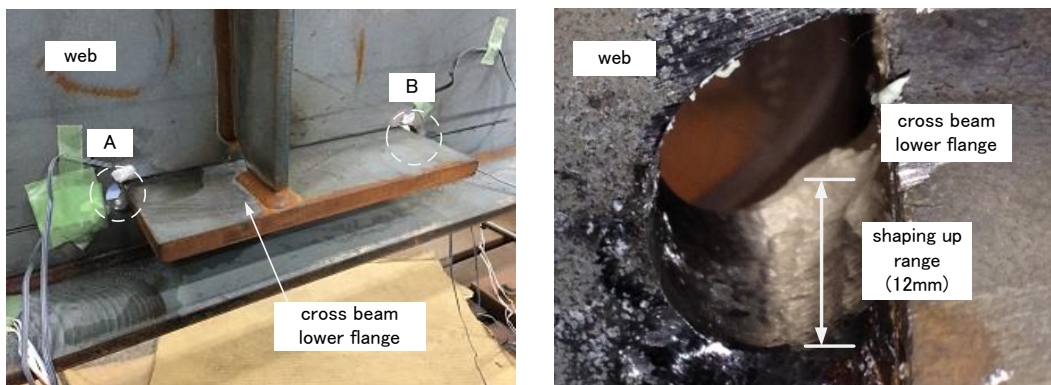
Photo 2. After crack removal and shaping up method (L2 (B))

Initial defects were removed and shaped up using a bar grinder in the lower welded specimen L2 (B). Photo 2 shows the condition after crack removal and shaping up of L2 specimen (B).

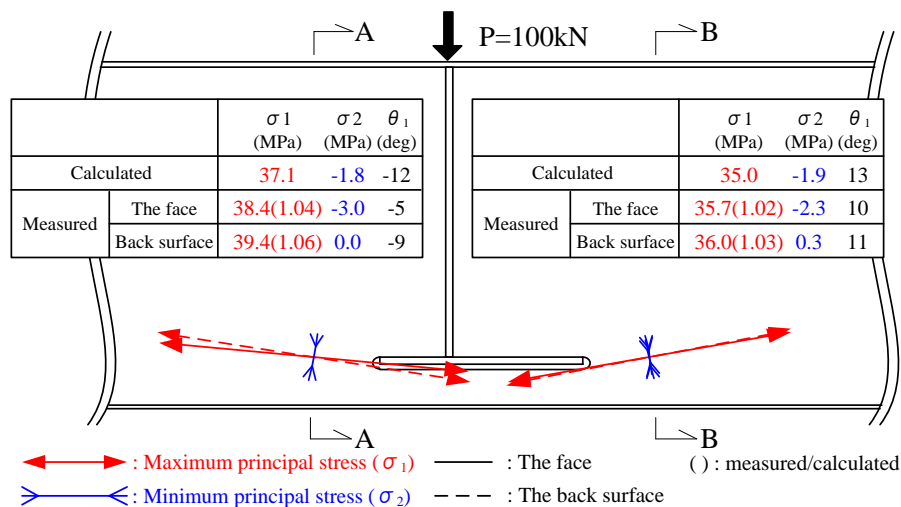
Figure 3. Principal stress distributions around web penetration details

Figure 3 shows principal stress distributions around web penetration details. Nominal stresses were obtained from bending moment and shearing force calculated according to the beam theory neglecting the cross beam lower flange and stiffeners. It was confirmed that the measured maximum principal stresses nearly equal to the calculated values, although the measured value was about 2~6% larger than the calculated one.

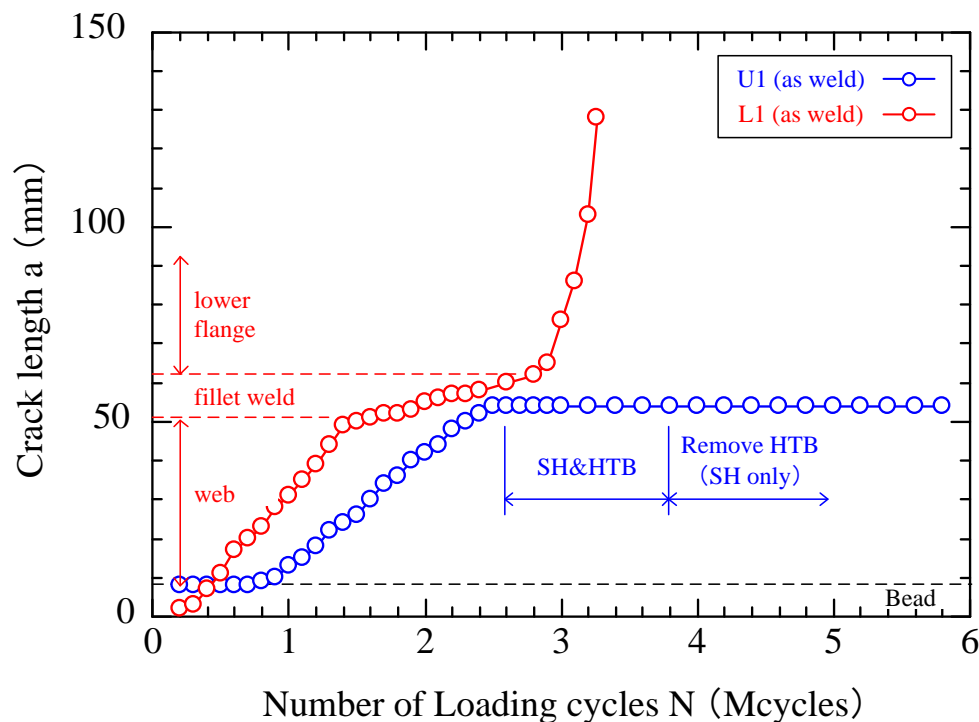
Figure 4. Relationship between the fatigue crack length and the number of loading cycles of U1 and L1

Figure 4 shows relationship between the fatigue crack length and the number of loading cycles for specimens U1 and L1. Fatigue cracks were initiated at the web-side toe of the fillet weld along cross beam lower flange edges.

In the U1 specimen (A), fatigue cracks were propagated into the web plate diagonally upward almost perpendicularly to the maximum principal stress direction. In the L1 specimen (A), fatigue cracks were propagated into the web plate vertically downward faster than in the case of the upper welded specimen, and broke the lower flange. Because the bending stress increases as approaching the lower flange of the main girder.

In the U1 specimen (A), both of SH method and SH and HTB method can stop crack propagation of long cracks as shown in Figure 4.

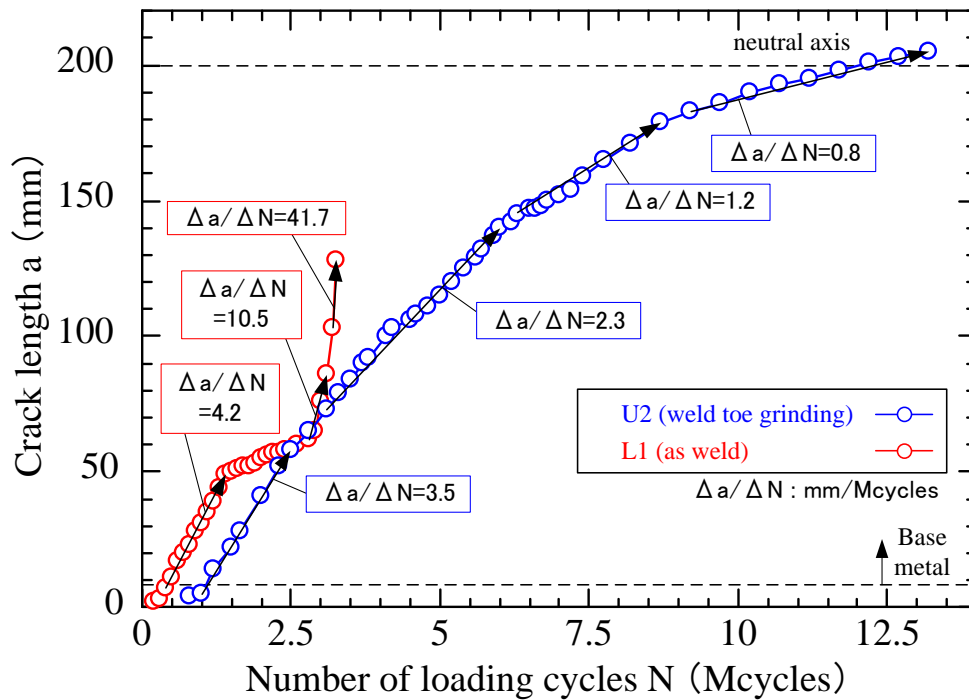
Figure 5. Relationship between the fatigue crack length and the number of loading cycles of U2 and L1

Figure 5 shows relationship between the fatigue crack length and the number of loading cycles of specimens U2 and L1. In the U2 specimen, crack propagation rate ($\Delta a/\Delta N$) becomes smaller as approaching the neutral axis. Because the bending stress decreases as approaching the neutral axis.

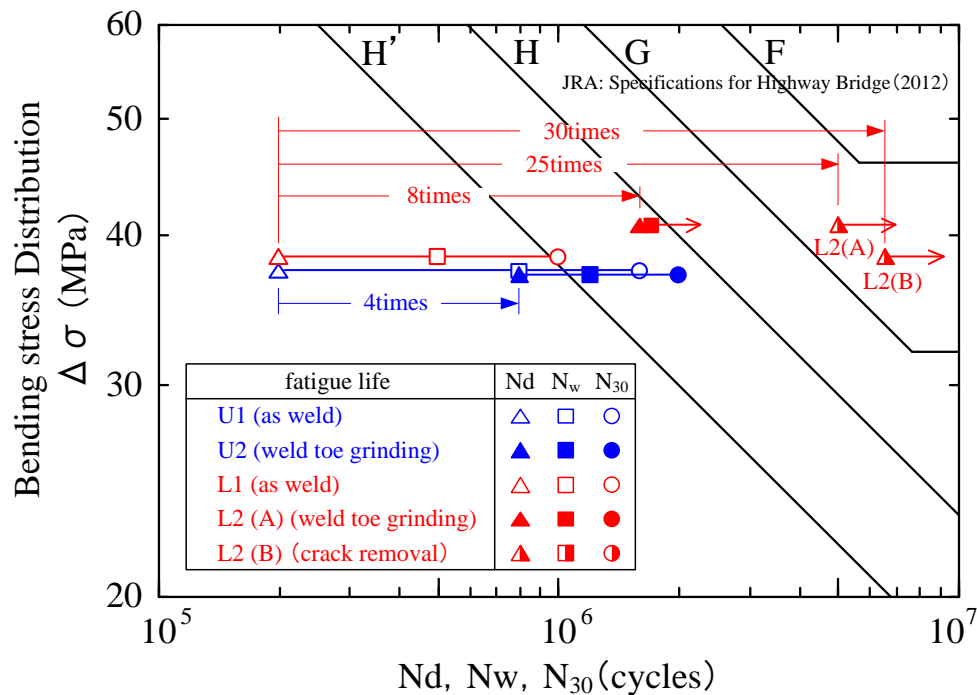
Figure 6. Fatigue life of specimens U1, U2, L1 and L2

Figure 6 shows the relationship between bending stress range and fatigue life of the specimens U1, U2, L1 and L2. In the U1 and L1 specimens (as weld), fatigue life when the crack was detected at web-side toes of the fillet welds along cross beam lower flange edges (N_d) is 1/5 of class H' (the lowest fatigue class in Japanese Specifications for Highway Bridges [6]), fatigue life when the crack was propagated into the web plate (N_w) was less than class H', and fatigue life when the crack length reaches 30mm (N_{30}) satisfies class H'.

Crack initiation life of U2 specimen was four times of that of U1 specimen (as weld) as shown in Figure 6, but fatigue cracks were propagated, similarly as U1 specimen, into the web plate diagonally upward almost perpendicularly to the maximum principal stress direction.

Therefore, this method can extend fatigue life a little, but cannot prevent fatigue crack initiation perfectly as shown Figure 6.

In the L2 specimen (B), no fatigue cracks were detected (see Figures 6 and 7). Therefore, crack removal and shaping up method can prevent fatigue crack initiation perfectly.

In the L2 specimen (A), crack removal and shaping up method by grinding can stop crack propagation of short cracks as shown in Figures 6 and 7.

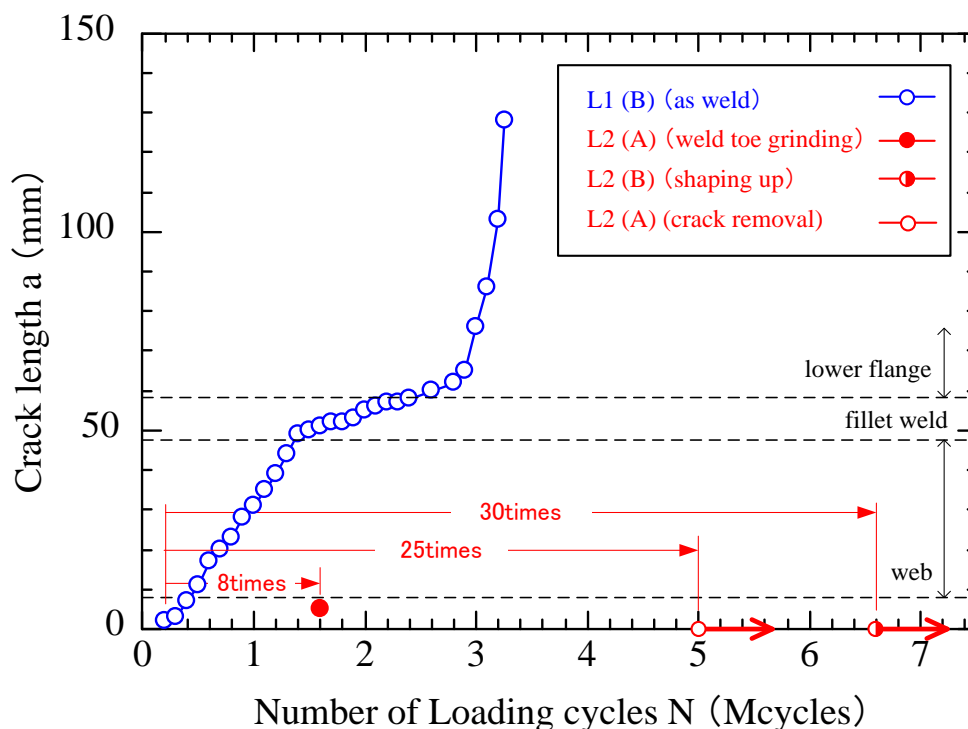
Figure 7. Relationship between the fatigue crack length and the number of loading cycles of L1 and L2

Figure 7 shows relationship between the fatigue crack length and the number of loading cycles of specimens L1 and L2. Crack initiation life of L2 specimen (A) is eight times of that of L1 specimen (B), but fatigue cracks were propagated, similarly as L1 specimen, into the web plate vertically downward.
